Date: Dec 08, 2020 Name: Spencer Robertson

Pieps DSP – A Beacon of Failure

An investigation into the events and repercussions of the failure of the Pieps locking mechanism: real life consequences and how it affects us as guides.

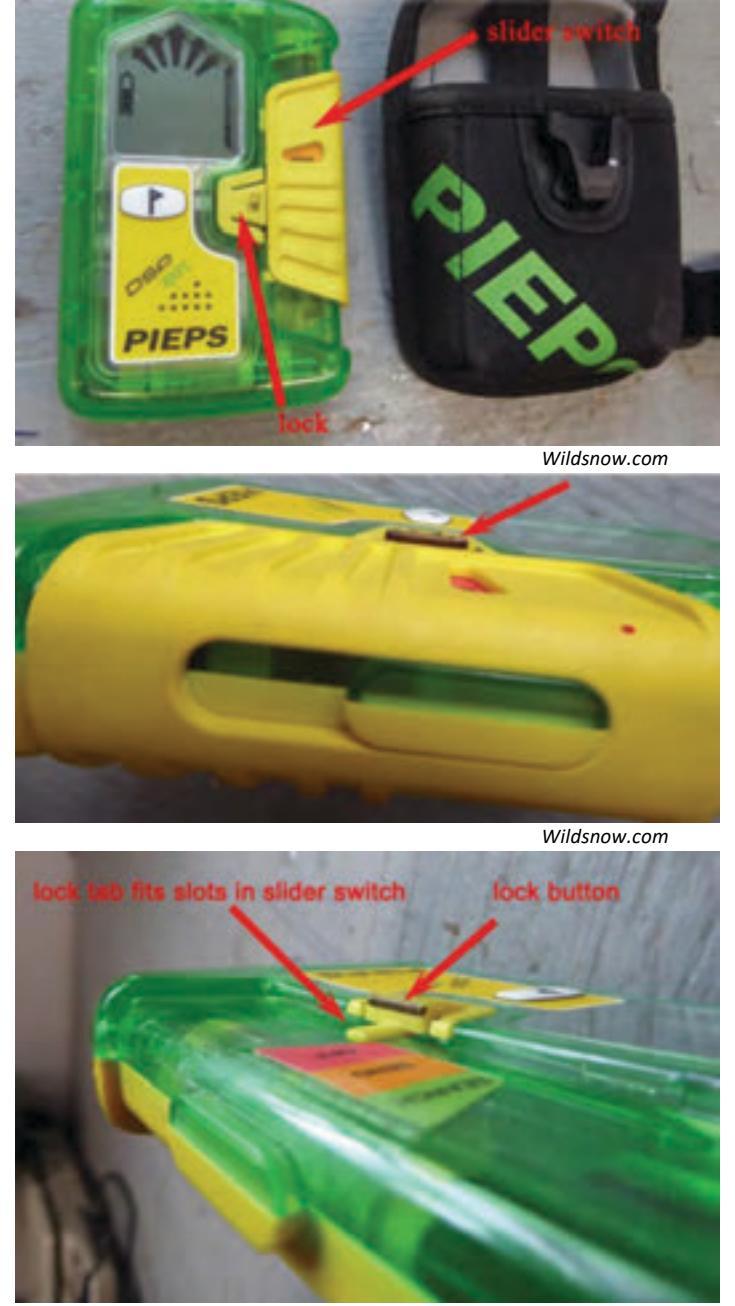
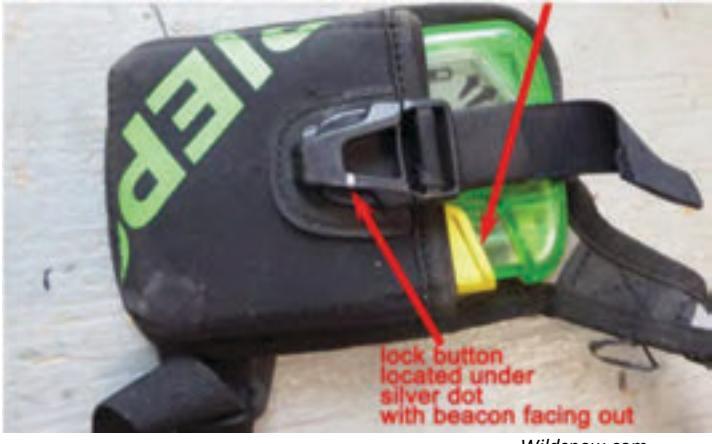
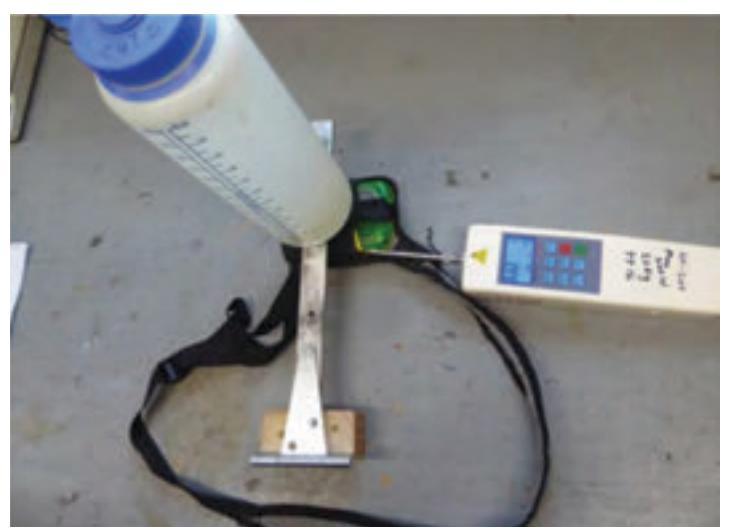
Lou Dawson from *wildsnow.com* did an extensive analysis of the Pieps DPS Sport and found that when the transceiver is placed backwards (screen facing out) in the harness by the user, it exposes the locking mechanism to external forces which may cause the unit to be switched to off or search mode, rendering the unit useless for a buried skier.

"It took **1,798 grams of weight on the buckle** to overcome any resistance of the case and depress the lock. Also, with the unit in the case, sliding the switch required **1**,440 grams of force-weight (and that force was noticeably reduced when I lubricated the slider with a spritz of water). Again, **not much pressure considering we're talking about a device designed for use by an avalanche victim doing things such as hitting trees at sixty miles per hour, not to mention being buried under thousands of pounds of snow.**" *Wildsnow.com*

From reading online forums, there are many arm chair critics offering solutions, but wildsnow.com instructs the public to simply apply duct tape to the device to ensure the lock stays in place. This appears to be an inadequate solution for such an important safety device.

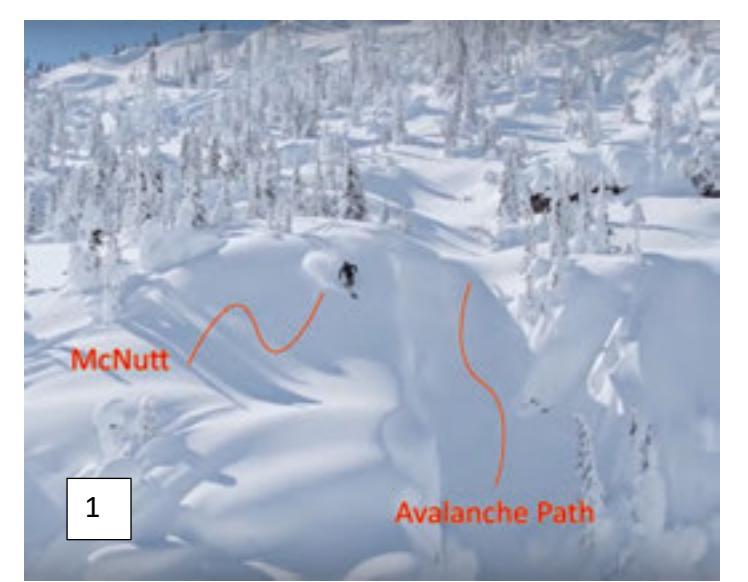
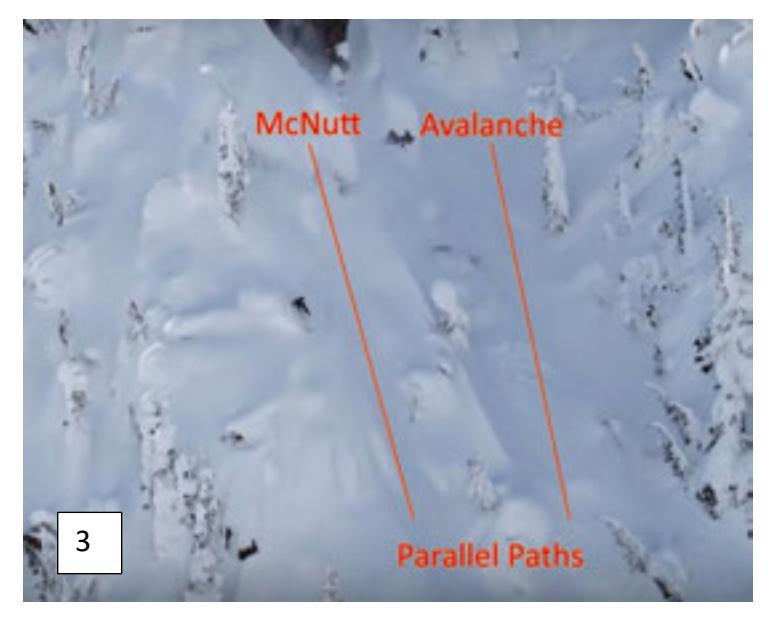
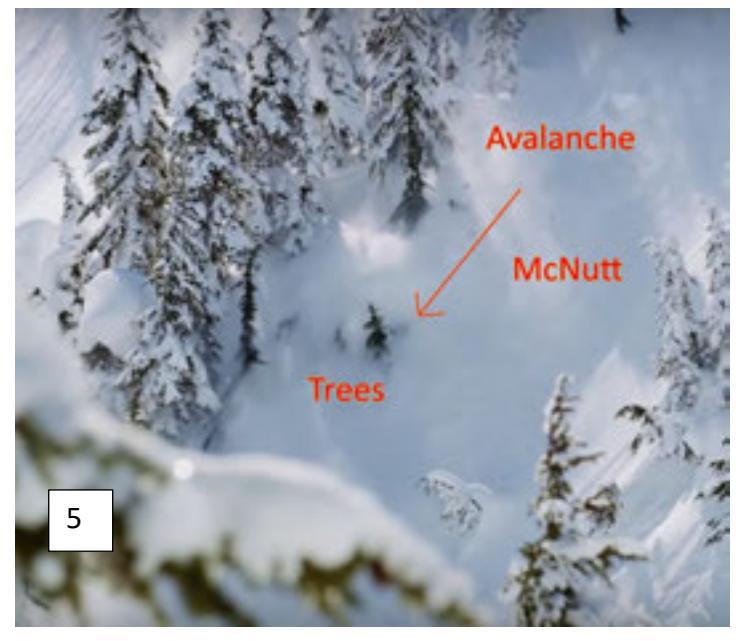
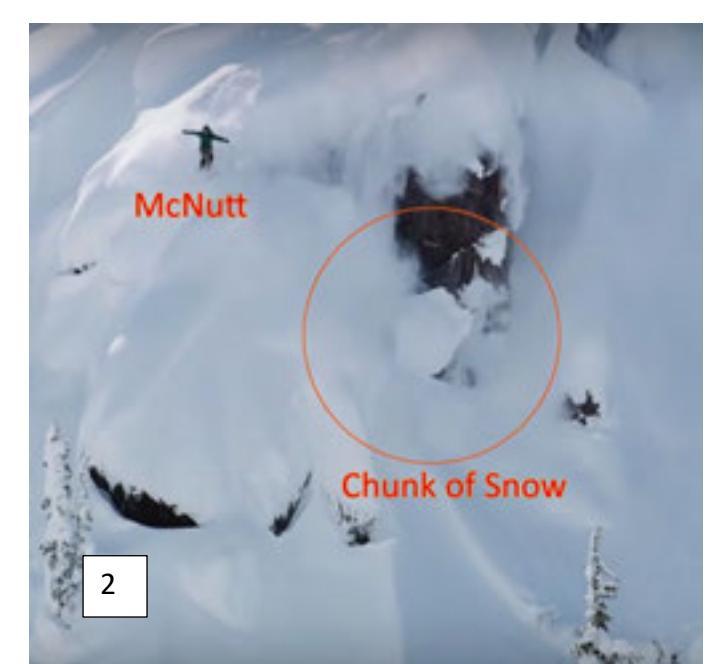
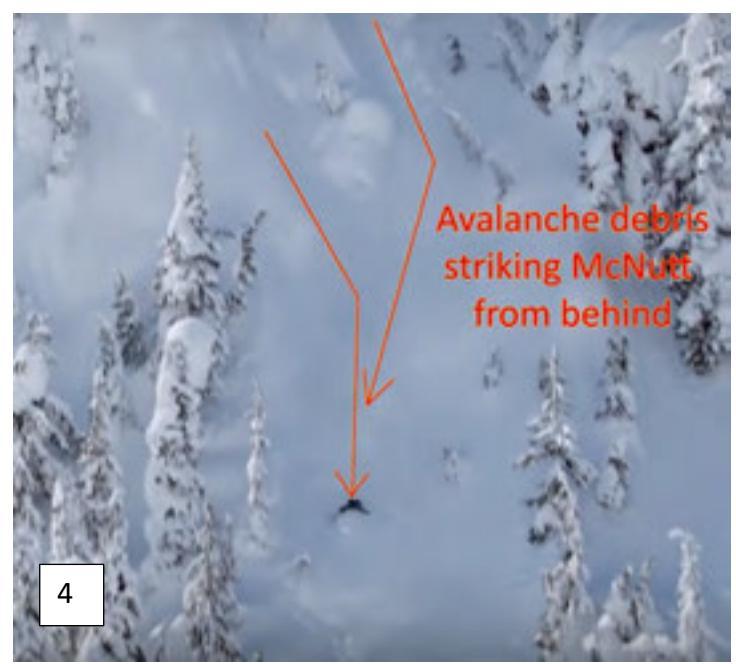
- 1 McNutt begins run
- 2 McNutt cuts large block of snow off top of cliff
- 3 McNutt and avalanche debris travel parallel
- **4** Avalanche debris catches McNutt and strikes his back launching him forward

5 – McNutt is slammed into the trees by the snow mass and presumably the transceiver is switched off

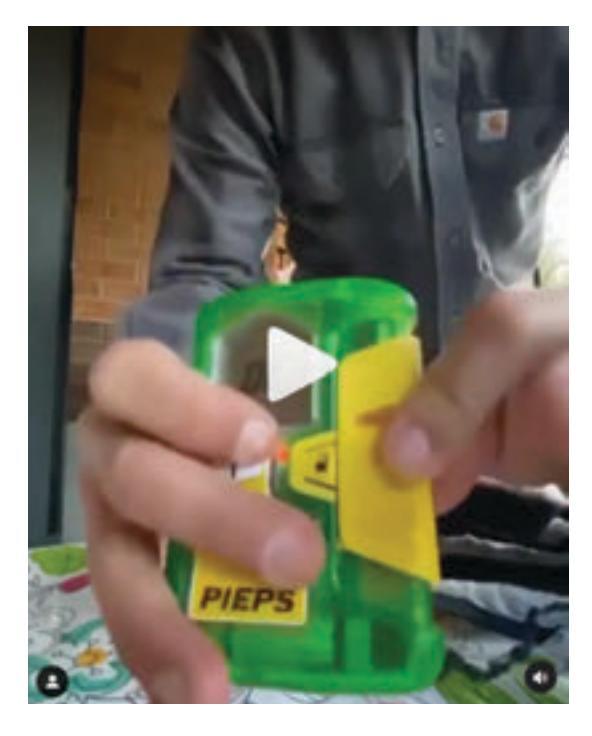
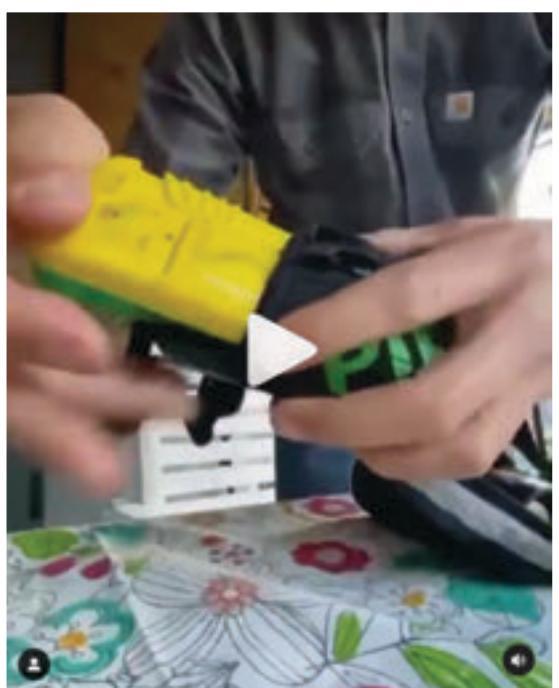
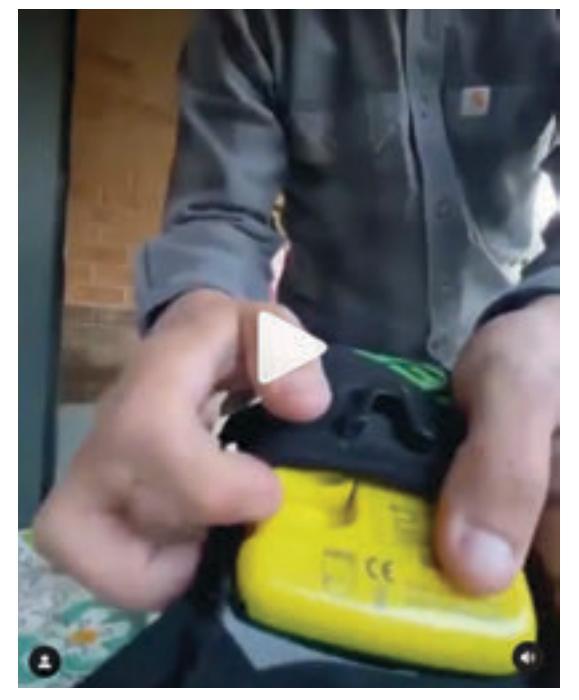
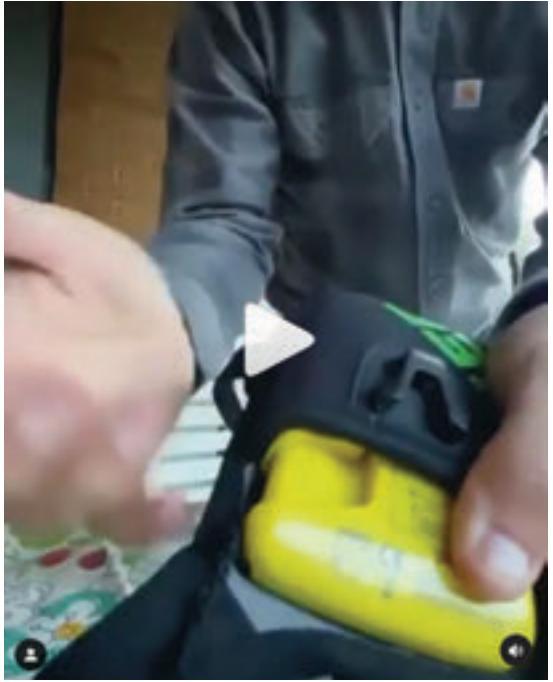
McCintosh also posted an additional video on October 20th, 2020 which demonstrated how easily the lock switch can be inappropriately moved even when inserted into the harness in the correct orientation.

- 1. McCintosh setting the transceiver to send and testing the lock
- 2. McCintosh inserting the device into the harness correctly
- 3. McCintosh applying minimal force to the lock
- 4. McCintosh showing that the lock released
