Date: Dec 08, 2020 Name: Spencer Robertson

Pieps DSP – A Beacon of Failure

An investigation into the events and repercussions of the failure of the Pieps locking mechanism: real life consequences and how it affects us as guides.

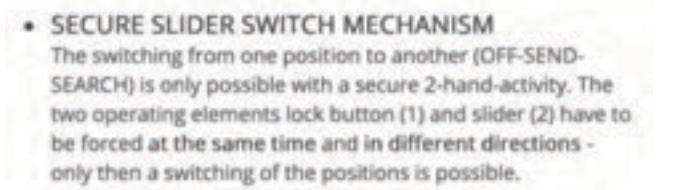
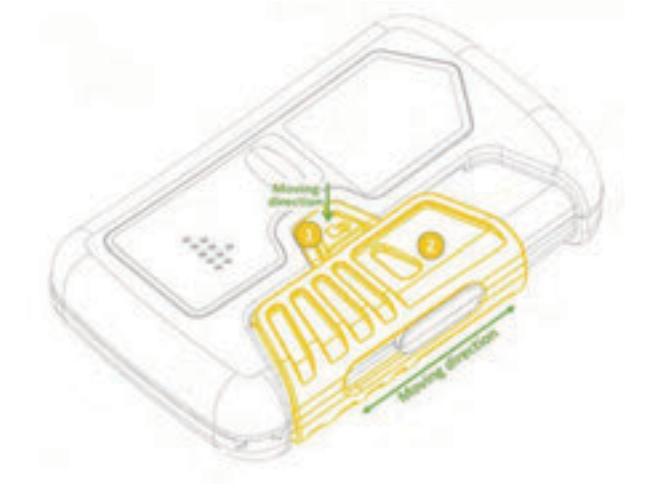
See instructions below from the Pieps DPS user manual on the function of the secure slider switch mechanism:

Lou Dawson from *wildsnow.com* did an extensive analysis of the Pieps DPS Sport and found that when the transceiver is placed backwards (screen facing out) in the harness by the user, it exposes the locking mechanism to external forces which may cause the unit to be switched to off or search mode, rendering the unit useless for a buried skier.

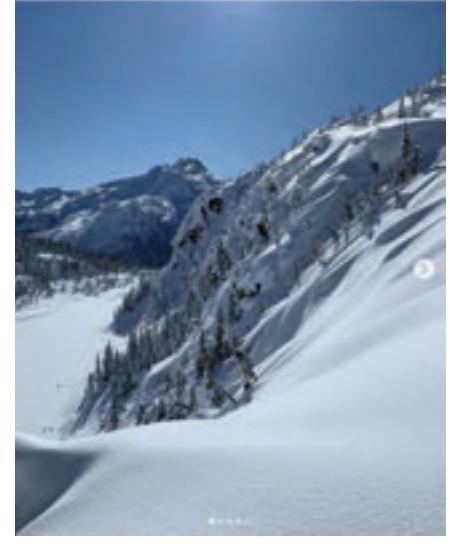
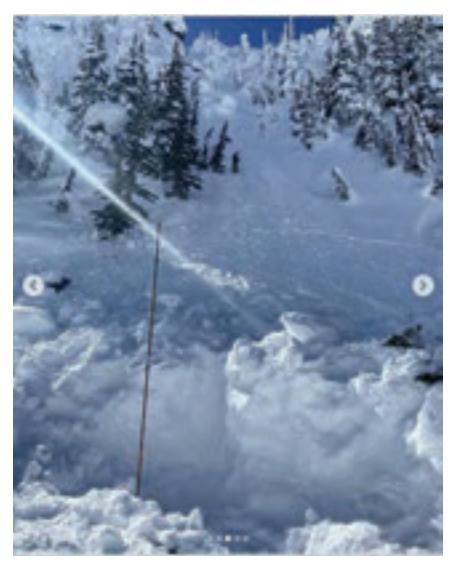
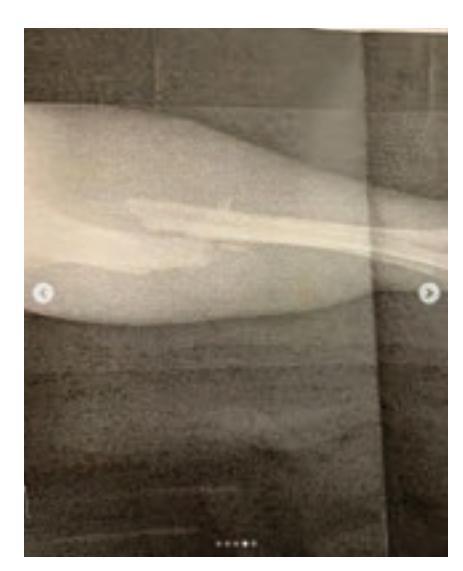
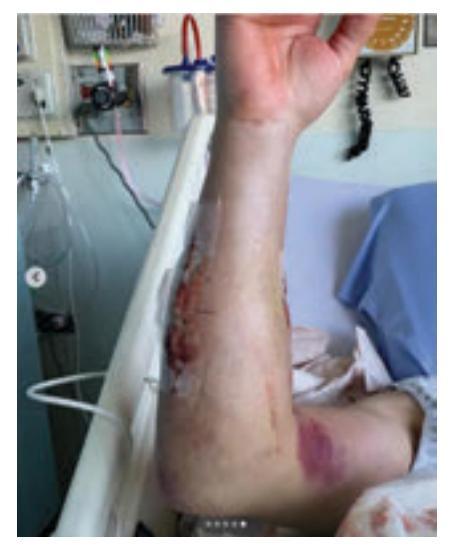
On Monday, March 9th I was involved in a serious accident near Pemberton. I'm writing this from the hospital in Vancouver (day 4) where I'm hoping I can leave soon. After a couple of great runs, I eyed up this nice-looking pillow rib line and to my misfortune, up high on the run, I broke a pillow off that sent hard chunks barreling down the gulley I was planning on exiting. As I finished the line, the chunks redirected me through trees and smashed me onto the lake, burying me 120cm down. For minutes I lied under the snow, holding on to faith that my friends who were close by would come to my aid. They prevailed through my beacon being smashed into the "off" position (no signal) and with a lucky probe strike, dug me out quickly.

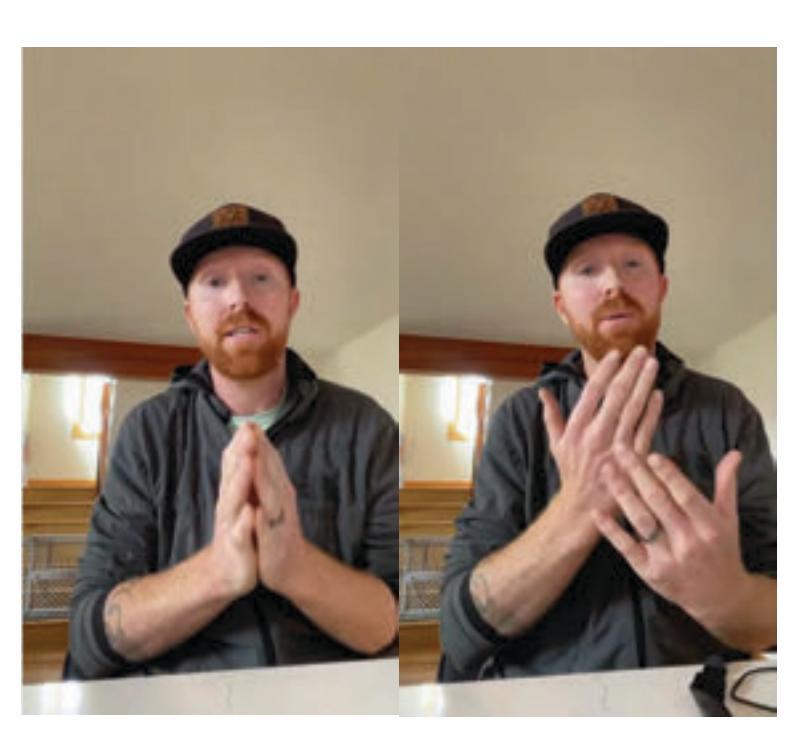
Ian McCintosh https://www.instagram.com/p/CGk2g_BnHhi/

Ian McCintosh, a professional skier who was a member of McNutt's rescue party, took to social media to make a call to action. TGR, as well as other members of the ski community, had been in contact with BD. TGR was not satisfied with Black Diamond's response. McCintosh posted a 9min and 25sec video to Instagram's IGTV explaining his experiences with the rescue and exasperation at his interactions with Black Diamond. Cody Townsend, another professional skier who has a large social media gathering, also leveraged his audience to call for a better response from Black Diamond.
